TYPE 2 ASBESTOS SURVEY

Client	North Kesteven District Council
Site	North Scarle Post Office, LN6 9LT.
Date started	19/2/2010
Date completed	19/2/2010
Date report issued	17/3/2010
Survey reference	S905/NO4/64
Lead surveyor	C Moore

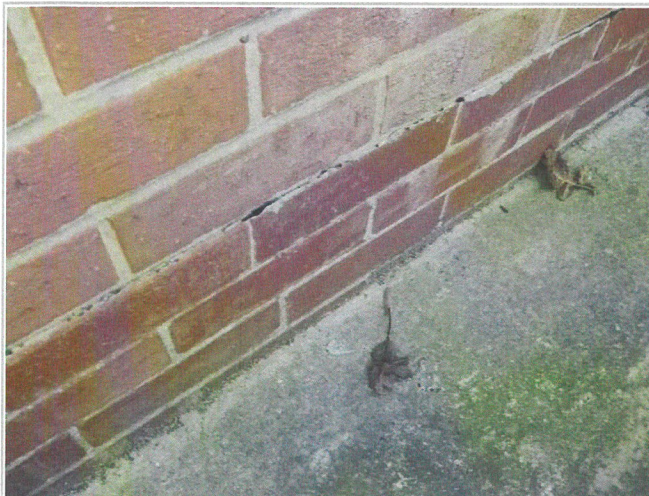
Comments / recommendation: Sample analysed no asbestos detected. No further action required.

Sample reference number	S905/NO4/64/002
Client name	North Kesteven District Council
Site address	North Scarle Post Office, LN6 9LT.
Date surveyed	19/2/2010
Date analysed	22/2/2010
Building	North Scarle Post Office
Floor level	External
Room	External
Position	Lower walls
Item description	Bitumen damp proofing
Condition / damage	N/A
Surface treatment	N/A
Product type	N/A
Asbestos type	No Asbestos Detected
Extent	N/A
Accessibility	N/A
Material assessment score	N/A
Risk code	N/A

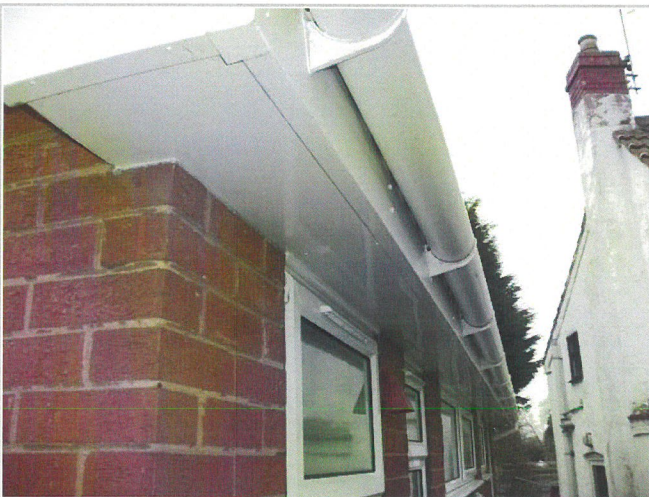
Sample	Building	Floor	Room	Position	Item desc	Conclusion	Assessment scores			Risk code	Date action completed
							Material	Priority	Total		
S905 / NO4 / 64 / 003	North Scarle Post Office	External	External	Front and rear gables	Cement fillets	Chrysotile	4	N/A	N/A	Risk code E

Sample reference number	S905/NO4/64/003
Client name	North Kesteven District Council
Site address	North Scarle Post Office, LN6 9LT.
Date surveyed	19/2/2010
Date analysed	22/2/2010
Building	North Scarle Post Office
Floor level	External
Room	External
Position	Front and rear gables
Item description	Cement fillets
Condition / damage	Low Damage
Surface treatment	Asbestos cement materials
Product type	Asbestos cement materials
Asbestos type	Chrysotile
Extent	10 m
Accessibility	Occasionally likely to be disturbed
Material assessment score	Very Low Risk (4)
Risk code	Risk code E

Recommendations							Very Low Risk				
Low risk ACM (Bound in matrix). Where appropriate label with warning signs. Undertake routine inspections for damage and deterioration. Where damaged, remove or repair in accordance with CAR2006. Reg 3(2).							Details of action			Action Timescale	Date action completed
							Next reinspection			Extent	
							19/02/11			10m

Comments / recommendation: Low risk ACM (Bound in matrix). Where appropriate label with warning signs. Undertake routine inspections for damage and deterioration. Where damaged, remove or repair in accordance with CAR2006, Reg 3(2).

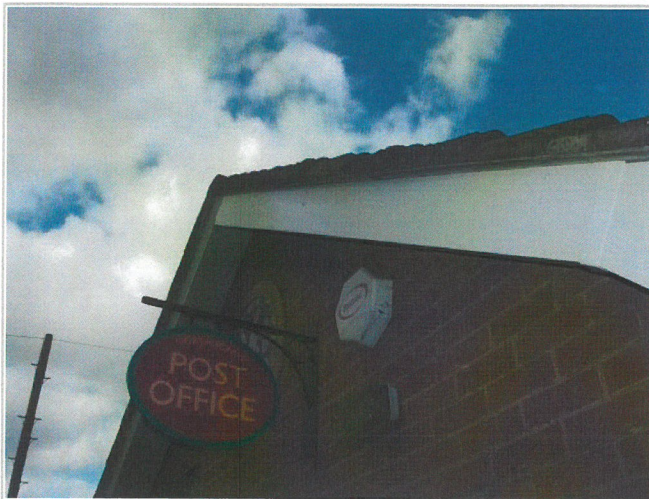
Sample ref no	Building	Floor level	Room	Position	Item	Access level
No sample ref 1 - Presumed	North Scarle Post Office	External	External	To eaves	Above plastic soffits	No Access

Comments / recommendation: No access above plastic soffits to eaves. Presume asbestos until proven otherwise.

Sample reference number	No sample ref 1 - Presumed
Client name	North Kesteven District Council
Site address	North Scarle Post Office, LN6 9LT.
Date surveyed	19/2/2010
Date analysed	
Building	North Scarle Post Office
Floor level	External
Room	External
Position	To eaves
Item description	Above plastic soffits
Condition / damage	N/A
Surface treatment	N/A
Product type	N/A
Asbestos type	No Access
Extent	N/A
Accessibility	N/A
Material assessment score	N/A
Risk code	N/A

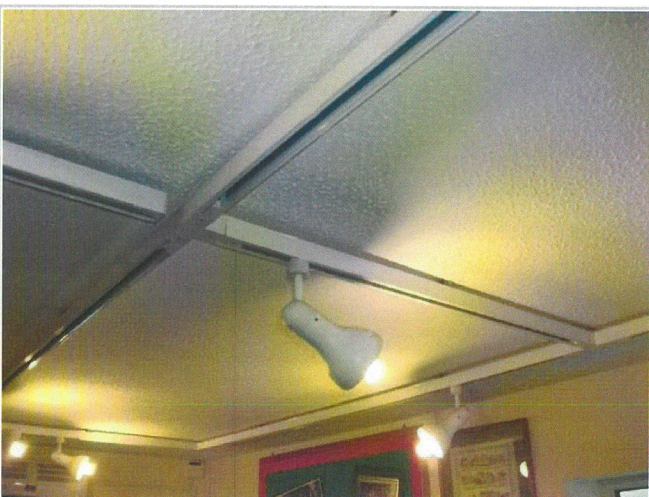
Comments / recommendation: Sample analysed no asbestos detected. No further action required.

Sample reference number	S905/NO4/64/001
Client name	North Kesteven District Council
Site address	North Scarle Post Office, LN6 9LT.
Date surveyed	19/2/2010
Date analysed	22/2/2010
Building	North Scarle Post Office
Floor level	Ground
Room	Post office
Position	Ceiling
Item description	Textured coatings
Condition / damage	N/A
Surface treatment	N/A
Product type	N/A
Asbestos type	No Asbestos Detected
Extent	N/A
Accessibility	N/A
Material assessment score	N/A
Risk code	N/A
